Subject: EPA Comments on “Draft Coal Combustion Residue Impoundment: Round 12 – Dam Assessment Report – City of Ames Power Plant”

January 3, 2014

This assessment of the stability and functionality of the City of Ames Power Plant Ash Pond and Lime Cell impoundment dikes is based on a review of available documents and on the site assessment conducted by Dewberry personnel on August 20, 2012. This is an unusual management unit configuration, because the Ash Pond operated by the City of Ames Power Plant shares an impoundment with the Water Department's Lime Cell. We found the supporting technical documentation incomplete (Section 1.1.3). As detailed in Section 1.2, there are two recommendations that would help to ensure a safe and trouble-free operation.

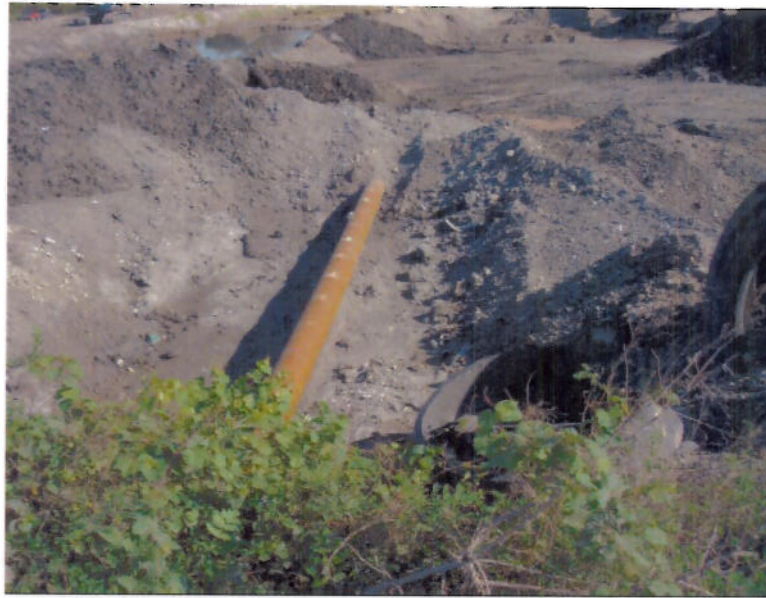
Photograph 2.2.2-1: Ash sluice pipe to Fly Ash Pond Receiving Ditch
the

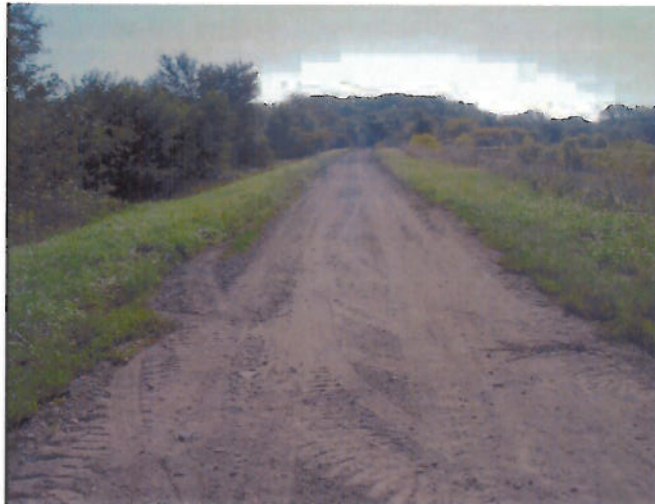
Overall, there were no signs of rutting, depressions, tension cracking, or other indications of settlement or shear failure and the crest appeared to be in satisfactory condition (see Figure 5.2.1-1).

Figure 5.2.1-1 North Dike Crest View East along ~~the~~ Ash Pond

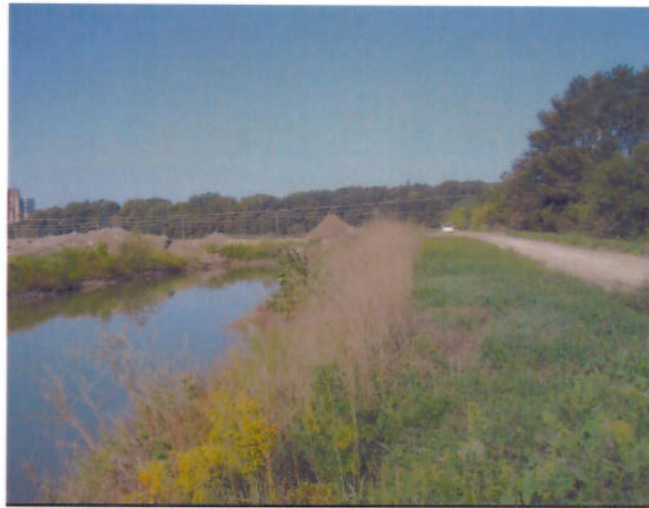
No scarps, sloughs, depressions, bulging or other indications of slope instability were observed (see Figure 5.2.2-1). Vegetation along the interior slope generally consisted of various types of grass and weeds. Small trees were observed along the interior slope of the south embankment. Areas of slope erosion were also observed along sections of the south embankment. The erosion was observed to be undermining trees growing on the slope (See Figure 5.2.2-2)

Figure 5.2.2-1 North Dike Interior Slope View
West along City Ash Pond

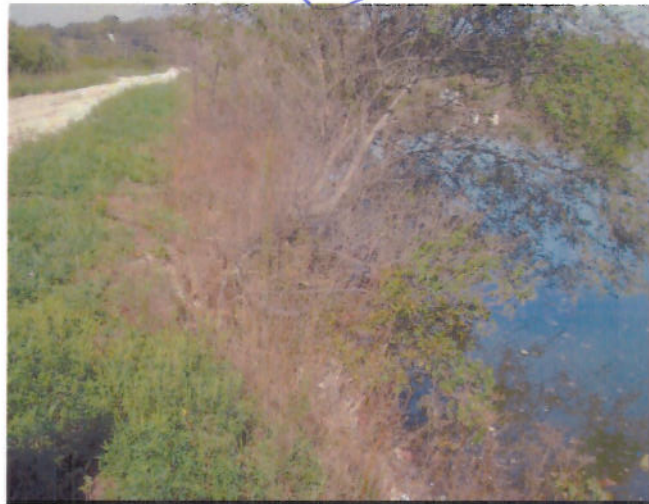
Figure 5.2.2-2 Erosion along Inside
Slope South Embankment

Regarding bullet 1, the repair of the interior portions of the Ash Pond is planned to commence this spring (2014).

- Repair interior embankment sections eroded by wind driven waves
- Remove trees from both the interior and exterior slopes of embankments.
- Modify the current inspection program to include weekly observation of the embankments.

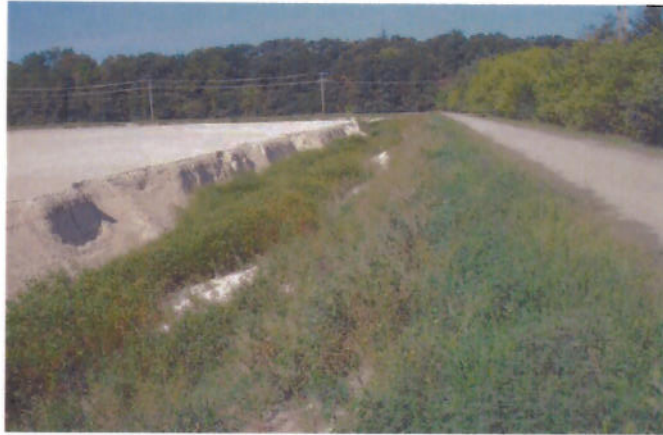
No scarps, sloughs, depressions, bulging, erosion, or other indications of slope instability were observed along the interior slopes of the Lime Pond (see Figure 5.2.2-3). Vegetation along the interior slope generally consisted of various types of grass and weeds.

**Figure 5.2.2-3: Lime Pond Interior Slope North
Embankment Viewing West**

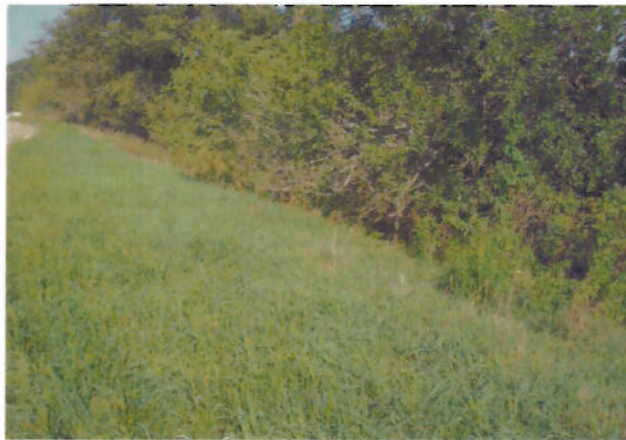
No scarps, sloughs, depressions, bulging, or other indications of slope instability or signs of erosion were observed. Exterior slopes were vegetated with grass, weeds, and sections of small to medium trees (See Figure 5.2.3-1).

**Figure 5.2.3-1: Outside Slope North
Embankment Viewing West**

No evidence of seepage was observed in the exterior slopes or along the toe of the embankments.

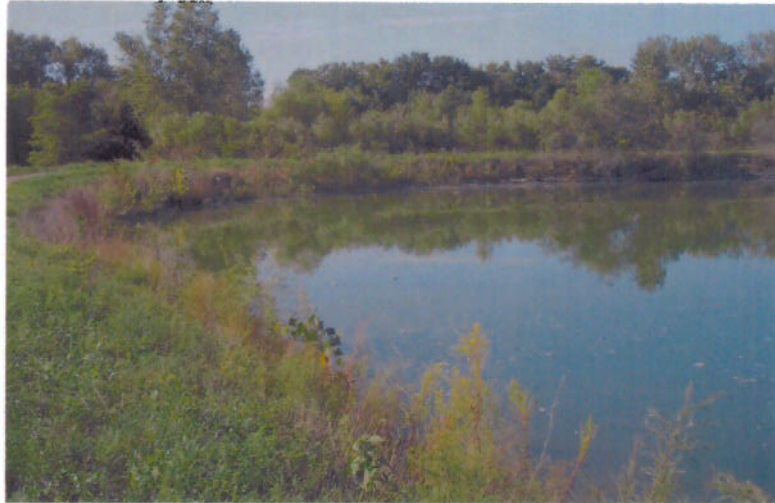
The Lime and Ash Pond ^{is} a fully diked and incised impoundment with no abutments. Groins were found to be in satisfactory condition with no signs of distress (See Figure 5.2.4-1)

Figure 5.2.4-1: Ash Pond Southeast Groin

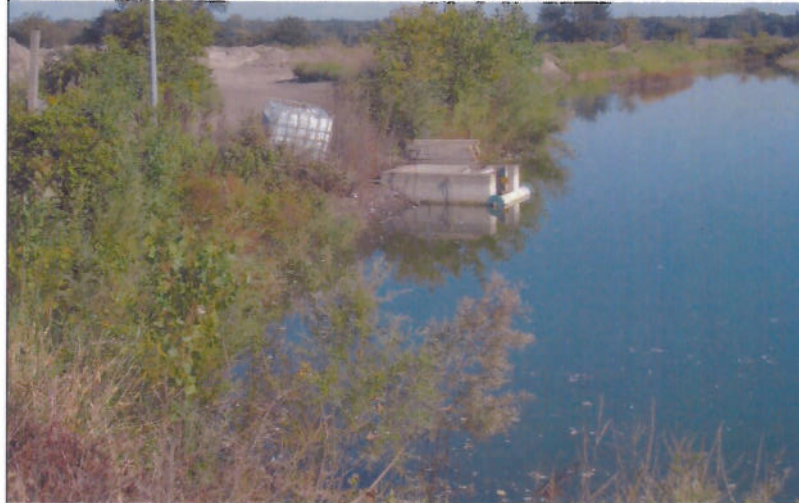
Figure 5.3.2-1 Ash Pond Outlet Structure

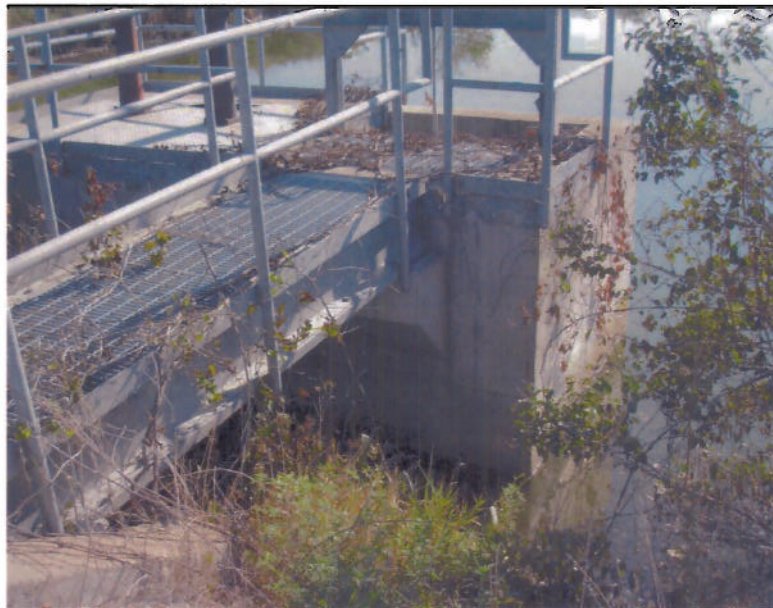
corner of the Fly Ash Pond. Flow through the pipes is controlled by a pair of butterfly valves located in a concrete manhole along a dike separating sections of the Clear Water Pond (See Figure 5.3.2-2).

Figure 5.3.2-2: Clear Water Pond Outlet Valve
Control Structure
